Water analysis report of the well under construction in the community of El Corozo Niquinohomo - Masaya, Nicaragua.

Chain of custody or third party water testing

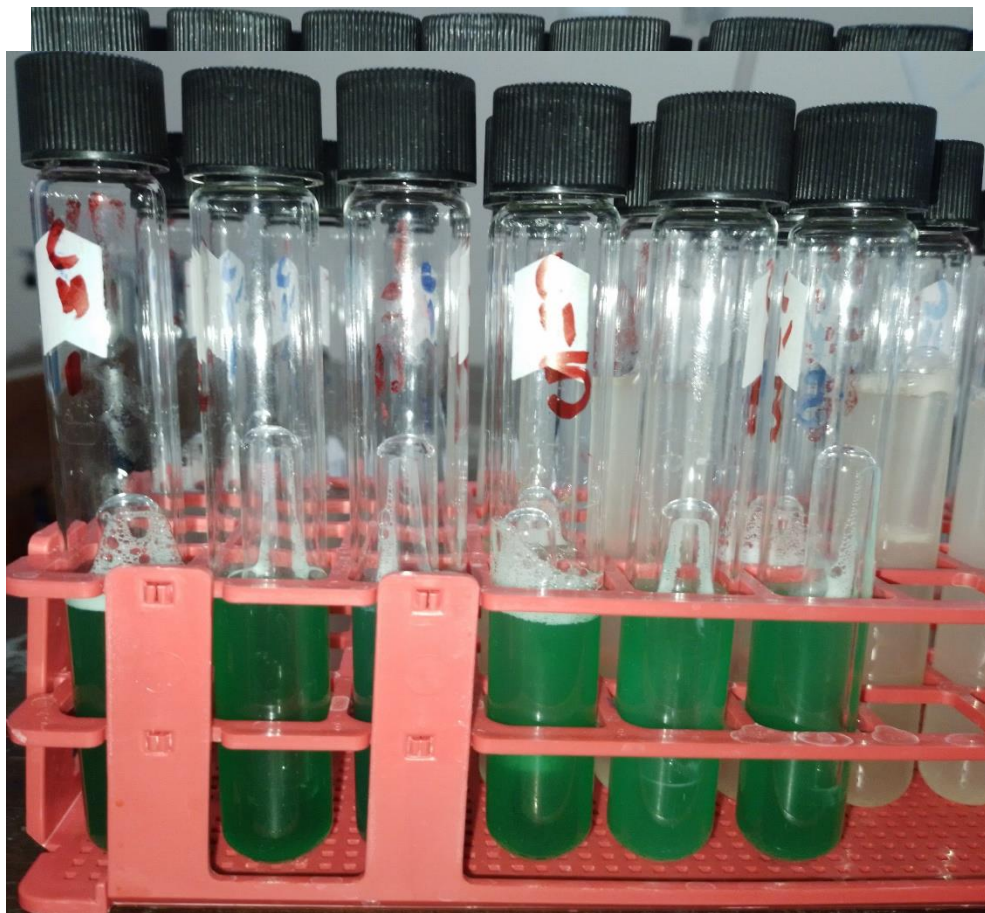
Figure 1. Presumptive total coliform analysis

According to the N.M.P. method with a reliability limit of 95% for various combinations of positive results, when 5 tubes are used for each dilution (10 ml, 1.0 ml and 0.1 ml), which consists of inoculating a diluted water sample in tubes containing selective liquid culture medium, and the aim is to know if there is any type of bacterial contamination. The result for total coliforms was 22 NMP/100 ml of positive sample for the group of total coliforms, exceeding the maximum admissible value of the CAPRE technical standard, which indicates less than or equal to 4 in 100 ml of sample.

It is recommended that a chlorination method be implemented to prevent the development of microorganisms, thus improving water quality at the microbiological and physical-chemical levels, and then perform another analysis to rule out the presence of microbiological contamination, including more specific analyses for the detection of individual bacteria such as E. coli of fecal origin only, thus guaranteeing the safety of the water from the El Corozo well.

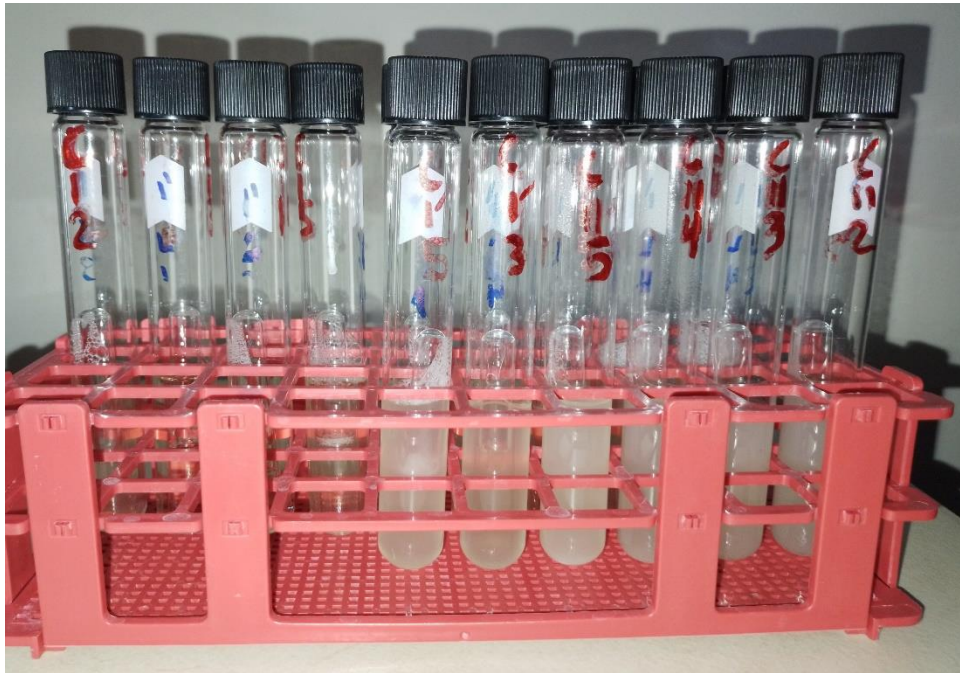
Figure 4. Fecal coliform analyses

While for fecal coliforms 17 NMP/100 ml of sample as a positive result demonstrating the presence of these microorganisms in a general way through the specific culture medium EC. This subgroup being the main indicator of microbiological contamination due to its specific origin in the intestinal tract of warm-blooded animals, including humans. Over passing both the recommended value and the maximum admissible value for this parameter according to the CAPRE technical standard, there should not be any presence of this group in water for human consumption.
